Hard Times for Small Craft: An Archaeological Survey of the  
Wright's Creek Abandoned Vessel Complex

Vessel 14 – Wright' Creek Abandoned Vessel Complex

Report for North Carolina SeaGrant  
Fund 211274

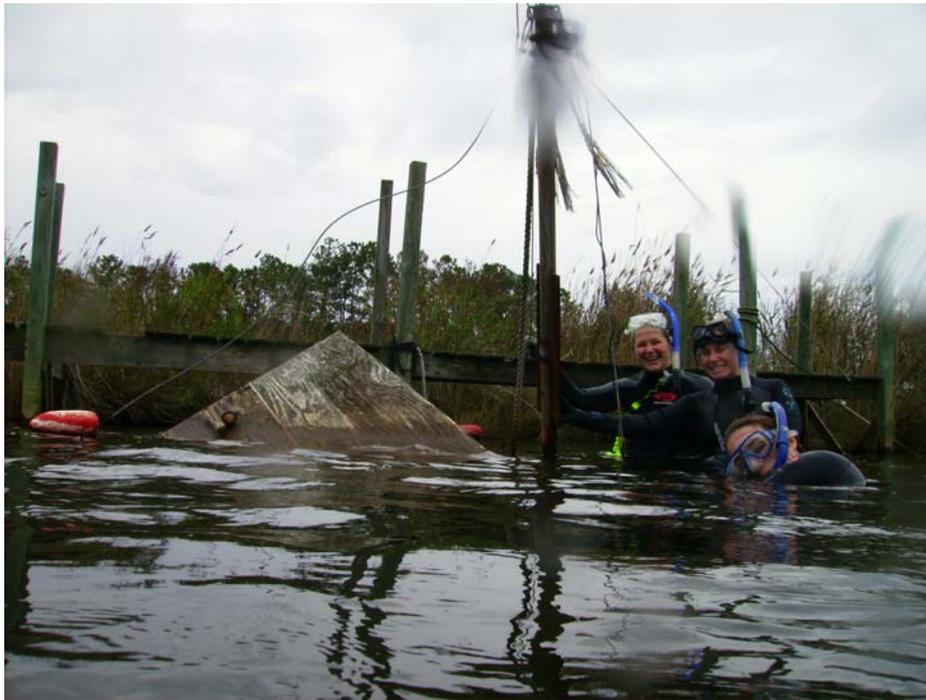
the creek at Contact0017, discovering immediately a small, wooden boat hereafter described as Vessel 14 (Appendix I). The vessel's attitude in the water is precarious as it rests in the silt listing to port, still tied to a decayed dock on its starboard side. Only the starboard corner of the pilothouse and the rusted rigging show above the water's surface (Figure 2).

**Figure 2: Grad students assisting with ground-truting on Vessel 14. From top: Morgan MacKenzie, Jeanette Hayman, and Lyz Wyllie. Photo by Jacqueline Marcotte October 2008.**

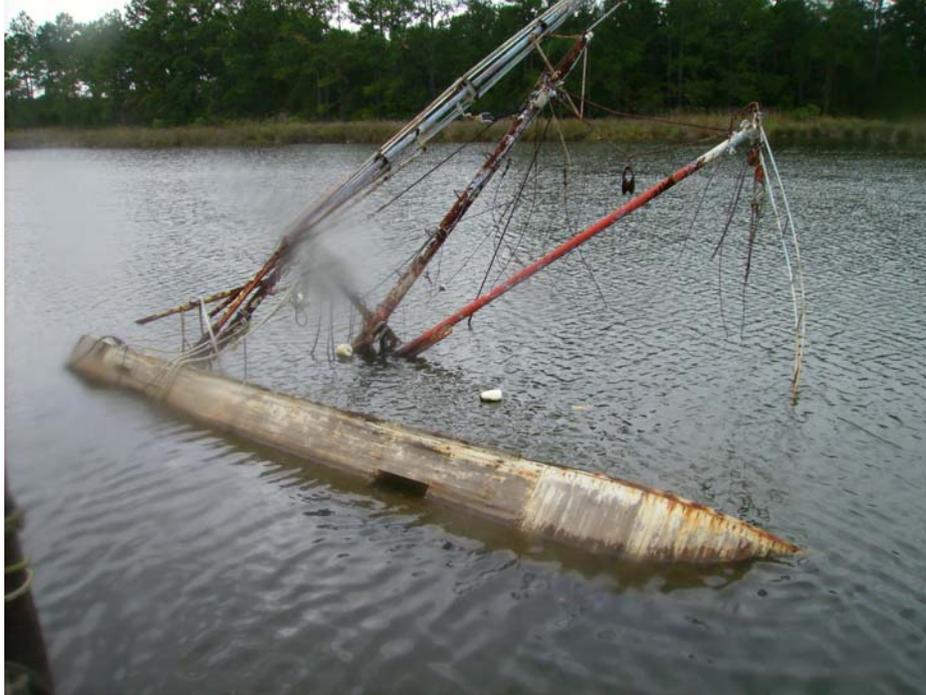
Proceeding directly north, investigators discovered the identity of Contact0018 as Vessel 1 (possible 0026PUR), previously recorded in spring 2008. Continuing on an eastward heading, investigators discovered the source of Contact0014 (Appendix I). This vessel is in a highly deteriorated state, with only a portion of the stern visible above the water, and a large amount of rusted rigging listing dangerously to starboard. During recording of the vessel's stern, large amounts of oil began belching from the vessel, and lines still tied to its stern danced dangerously near investigators in the water. Due to these complexities, the dive safety officer deemed Contact0014 too dangerous to dive or investigate from close proximity (Figure 3).

**Figure 3: Contact0014, abandoned vessel across from Foster's Seafood Landing.**

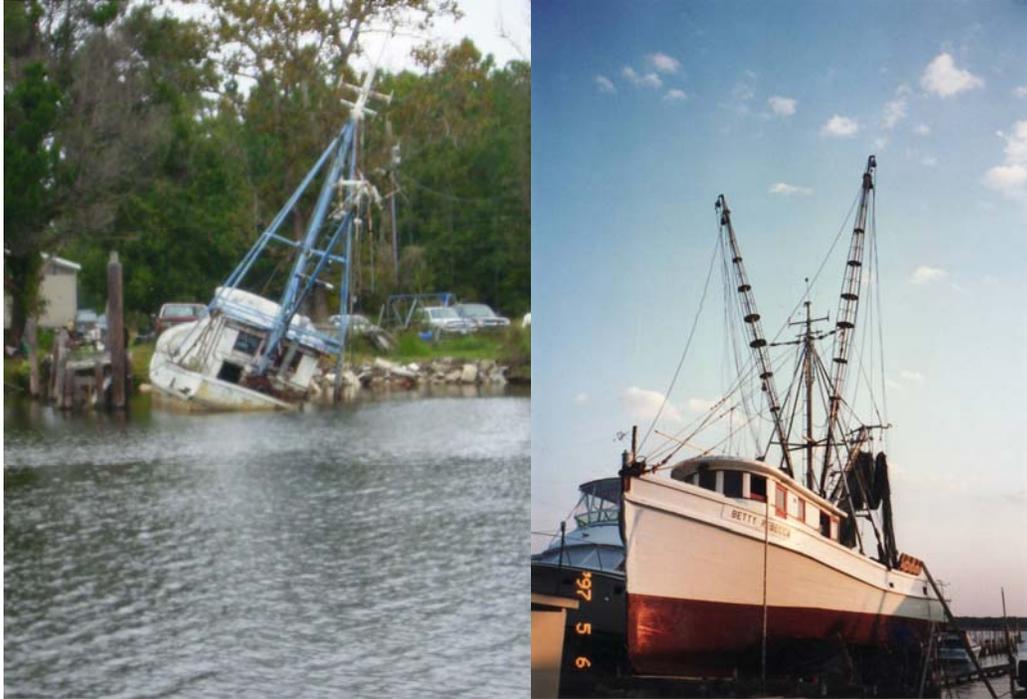
Continuing in a northeast heading, investigators encountered the source of Contact0021, an abandoned vessel located in front of Foster's Seafood (Appendix I). This vessel is the *Betty Rebecca*, a 54 ft. wooden trawler built by Major Wilson Foster, and area resident, in the 1970s (Figure 4). The final two anomalies, Contact0007 and Contact 0008, were tracked to the south prong of Wright's Creek (Appendix I). Unfortunately, they lie beneath two working fishing vessels, the *Brittany Faye* and *Cathy Gail*. For this reason, the dive safety officer allowed no further investigation of the anomalies, which appear as curious, almost oblong shapes in the sonar image.

**Figure 4: The *Betty Rebecca*, built by Major Wilson Foster in the 1970s. Left: *Betty Rebecca* awash during October ground-truthing, photo by Jacqueline Marcotte. Right: *Betty Rebecca* in 1997, photo courtesy Captain Carl Wilson Foster.**

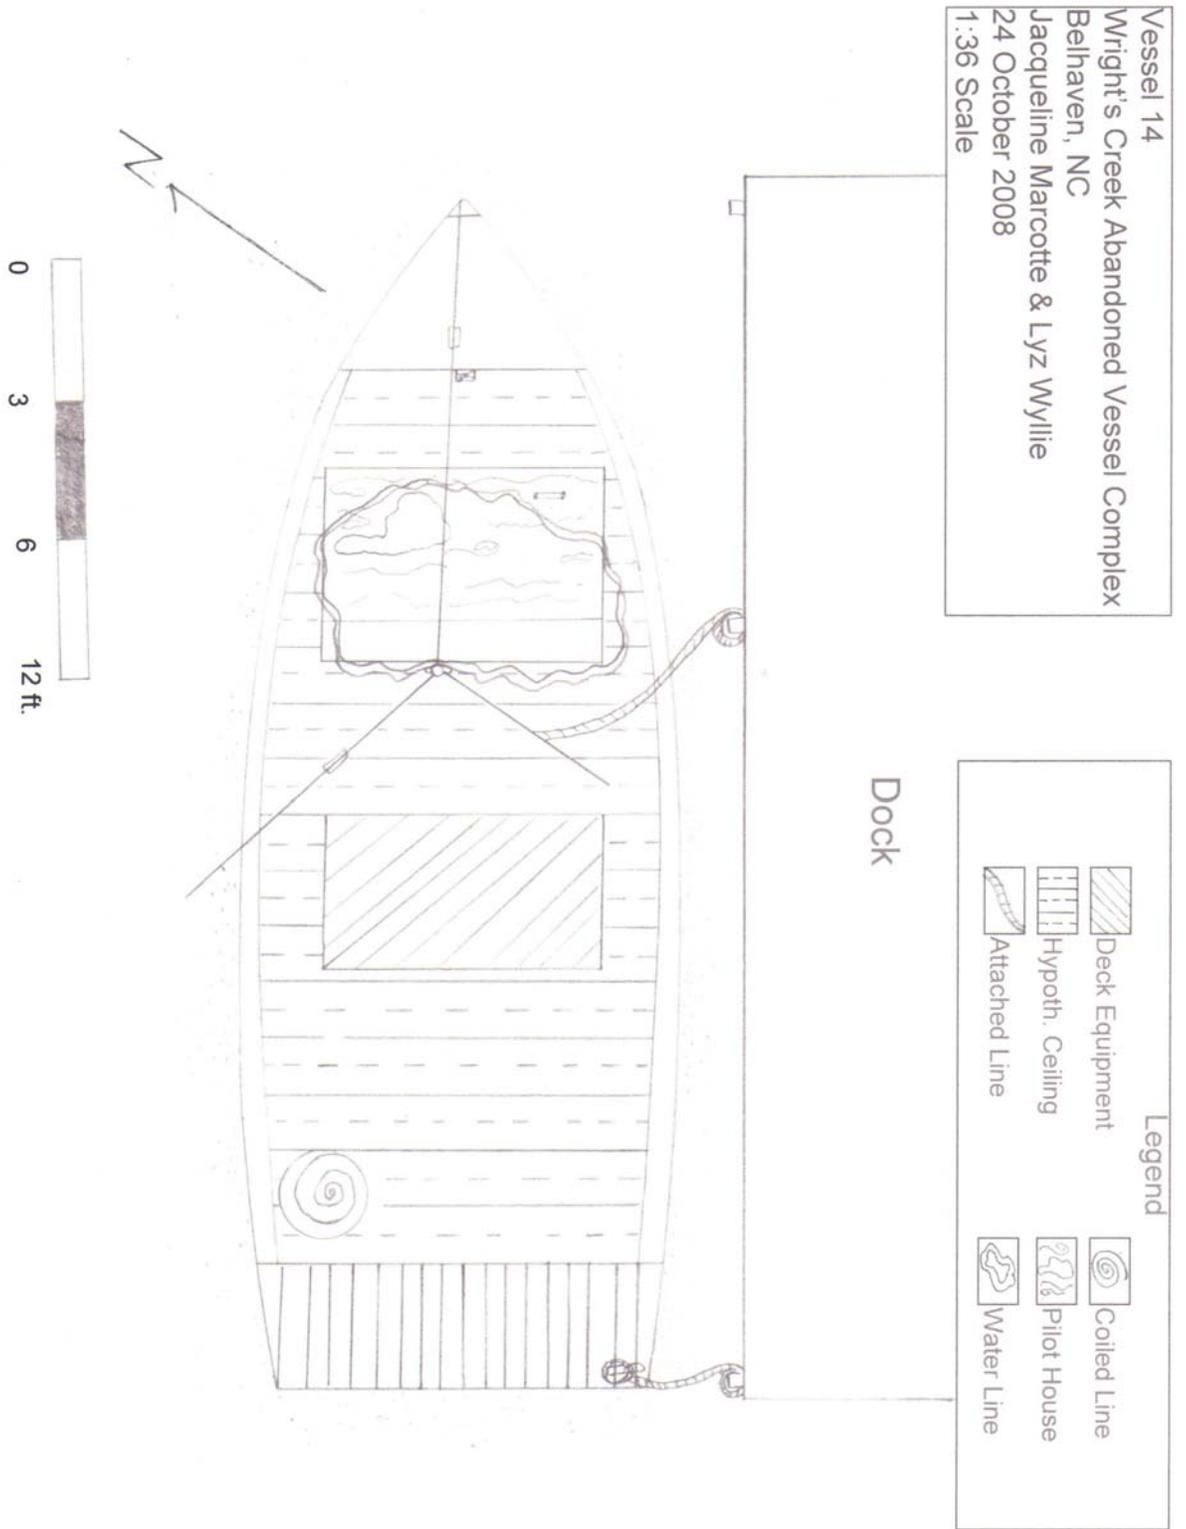
Using this method, approximate vessel dimensions were recorded as 26 ft. length, and 8 ft. beam. The vessel rests at a depth of 8 ft., with a portion of its rigging and pilothouse still visible above the water's surface. Portions of the internal structure of the hull bottom are visible through tannin stained water and mud on the starboard side, but measurements were difficult to acquire, and the lack of visibility made timber alignment difficult to discern. Although set up for motorized propulsion, the vessel's motor is no longer extant.

The scaled site plan (Figure 5) reveals the location of prominent features in relation to the baseline, such as the extant hull line, pilothouse, sampson post, and raised forward and aft decks. Site and historic photographs disclose pertinent information regarding cultural and natural transforms on the site, and aid in our understanding of construction. The wavy lines encompassing the pilothouse reflect the waterline; the entire vessel is submerged save this small portion. An interpretation of ceiling or deck planking is noted with solid and dashed lines. Toward the midline of the vessel, deck equipment still exists, but only a glimpse of this was visible during survey and has been delineated with diagonal lines. Although decking was not located, it is likely extant as glimpses of fishing equipment still attached to the vessel occurred briefly during breath-hold dives. Placement assurance in the form of small, cross-hatched lines is depicted attaching the boat to the dock, and straight lines moving away from the boat, and toward the stem, represent the remainder of the rigging.

Figure 5: Vessel 14 - a 26 ft. x 8 ft. wooden fishing vessel built by Major Wilson Foster, area resident.

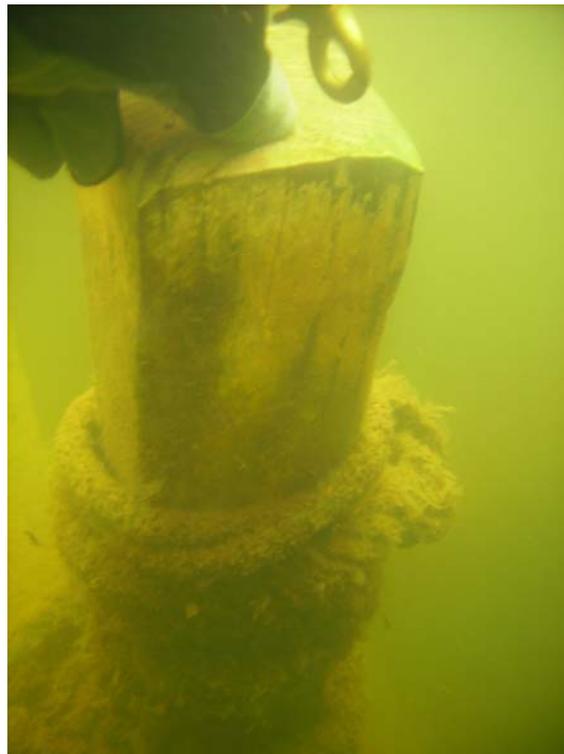
A sampson post sits approximately 3.6 ft. abaft the stem, with line still attached around its body (Figure 6). The remains of a raised forward deck span the expanse between the stem and the forward part of the sampson post, floating unattached to port or starboard planking. The vessel has a raised deck with longitudinal planking at its transom stern section. In addition, the rub-rails or guards have a slight, rounded flair. The pilothouse is located forward midships, approximately 5.2 ft. feet from the stempost.

**Figure 6: Vessel 14's sampson post located in the forward section 3.6 ft. abaft the stempost. Note the aft edge of the raised decking to the left.**

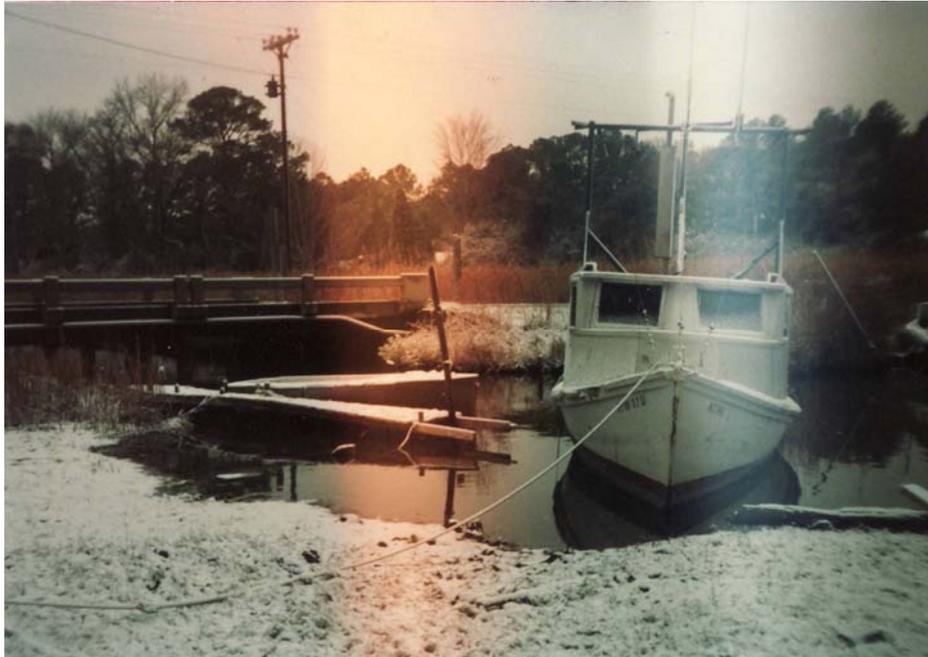
The historic photograph of Vessel 14 yields views of the vessel's bow, hull, and pilothouse, recording the vessel's condition sometime prior to discard (Figure 6). The vessel's rigging appears in tact, attached to the stempost. Wear is present on both the stempost of Vessel 14, and the starboard rub-rail, as large gashes expose unpainted wood. A sampson post is visible some distance abaft the stempost, with line wrapped around it securing the vessel to shore. The

exact location of the vessel during the taking of this photograph is unknown, although it is likely within Wright's Creek, as the owners of the vessel, the Fulford family, are area residents (Personal Communication, Carl Wilson Foster, 16 April 2009).

**Figure 7: Vessel 14 in working condition, built by Major Wilson Foster, a Wright's Creek resident and boatbuilder.**

There is no known abandonment date for this vessel, but it appears to be in an advanced state of deterioration, comparable to vessels surveyed near Schoolhouse Landing in spring 2008. Placement assurance can be seen in the form of lines still attaching the sunken vessel to its decaying dock (Figure 7). The vessel's forward, raised deck is deteriorated, only a small portion remains attached to the stempost.

The lack of rigging remaining on the vessel, and its lack of a motor may in fact demonstrate salvage of gear and equipment before purposeful abandonment. For the purposes of this discussion, abandonment of a vessel is defined as one that has been "relinquished, left, or given up by the lawful owner without the intention to later resume any right or interest in the vessel" (Hills 2007:21). Salvage is an example of cultural transforms occurring in the

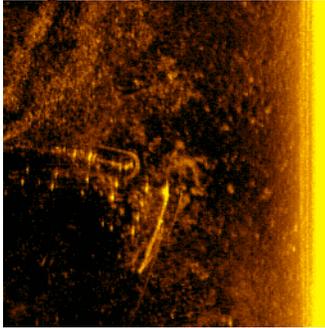
### Contact0007

Target Description:  
Target Height = 0.00 Meters  
Target Length: 10.60 Meters  
Target Shadow: 0.00 Meters  
Target Width: 3.97 Meters

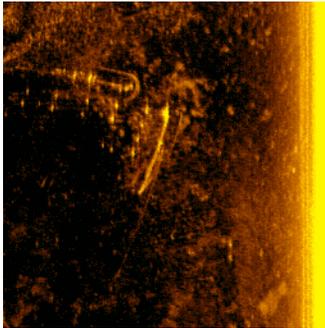
### Contact0008

Target Description:  
Target Height = 0.00 Meters  
Target Length: 9.53 Meters  
Target Shadow: 0.00 Meters  
Target Width: 2.33 Meters

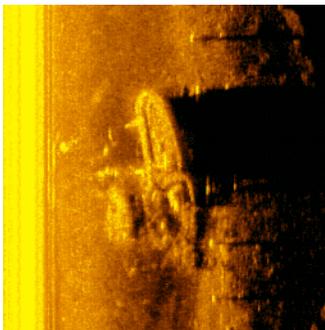
### Contact0014

Target Description:  
Target Height = 0.60 Meters  
Target Length: 13.38 Meters  
Target Shadow: 7.62 Meters  
Target Width: 3.34 Meters

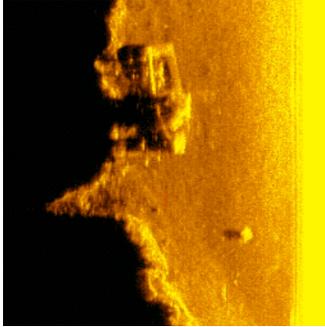
#### Contact0017

Target Description:  
Target Height  $\geq$  0.33 Meters  
Target Length: 6.13 Meters  
Target Shadow: 3.52 Meters  
Target Width: 2.50 Meters

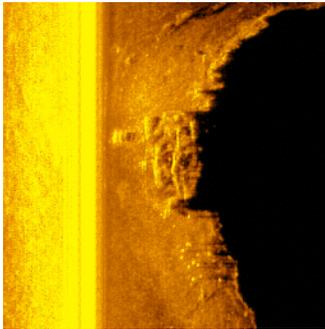
#### Contact0018

Target Description:  
Target Height  $\geq$  0.40 Meters  
Target Length: 9.81 Meters  
Target Shadow: 2.39 Meters  
Target Width: 3.42 Meters

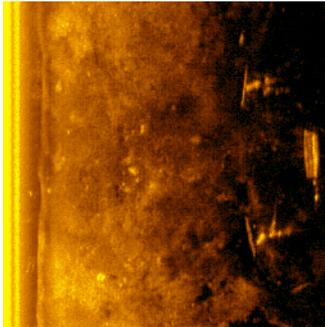
#### Contact0021

Target Description:  
Target Height = 0.00 Meters  
Target Length: 5.87 Meters  
Target Shadow: 0.00 Meters  
Target Width: 1.33 Meters
